Navajo Abandoned Uranium Mine

Site Screen Report

Mine Name: Tract 24 Mine - A
Mine ID: 391

Navajo AUM North Central Region

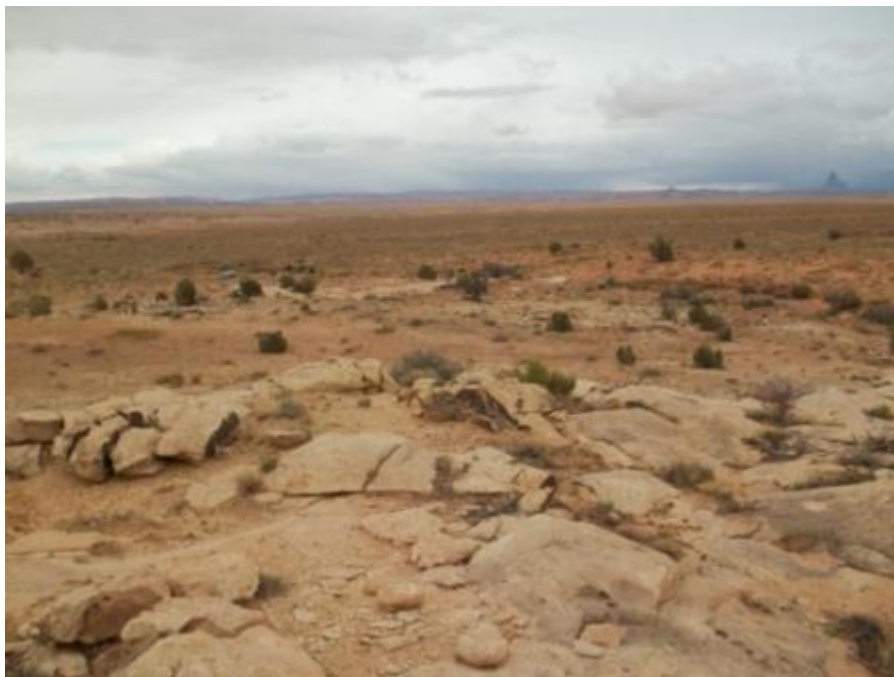
Photo 1

Mine Site #391

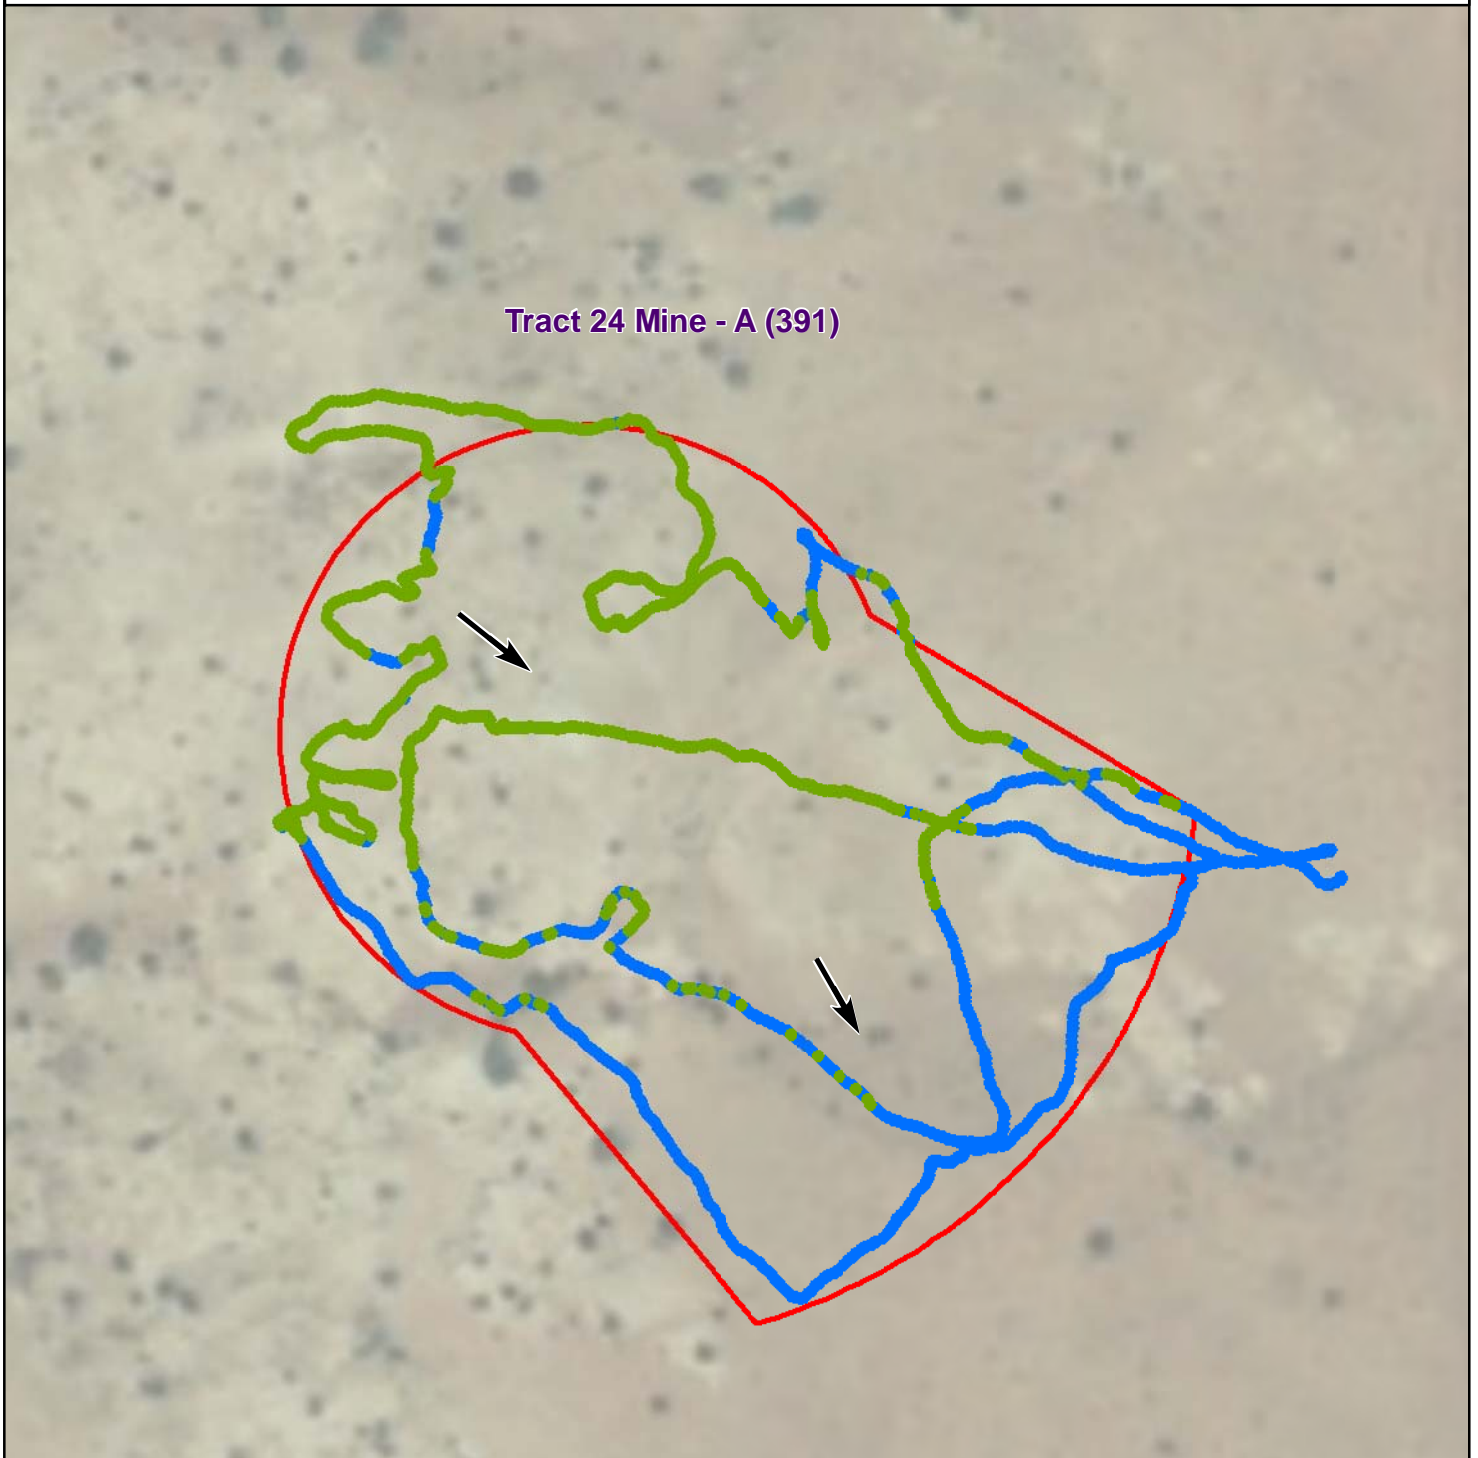
Figure 2 - Gamma Radiation Measurements
Tract 24 Mine - A (391)
Oljato Chapter, Navajo Nation

Gamma Radiation Measurements

- 0 - 10,000 cpm
- 10,000 - 25,000 cpm
- 25,000 - 50,000 cpm
- 50,000 - 100,000 cpm
- 100,000 - 250,000 cpm
- 250,000 - 500,000 cpm
- 500,000 - 1,000,000 cpm

Average background 6,786 cpm

Measured as counts per minute (cpm)

A total of 1,623 gamma radiation measurements were collected from the mine site, ranging from 4,873 cpm to 23,461 cpm. The measurements are represented in Figures 1 and 2.
